ASBESTOS ASSESMENT AND SURVEY

Prepared for: Public Works Department - City of Sweet Home

Property Address: 1357 Pleasant Valley Rd. Sweet Home OR. 97386

Demolition - Out Buildings - Administration Building

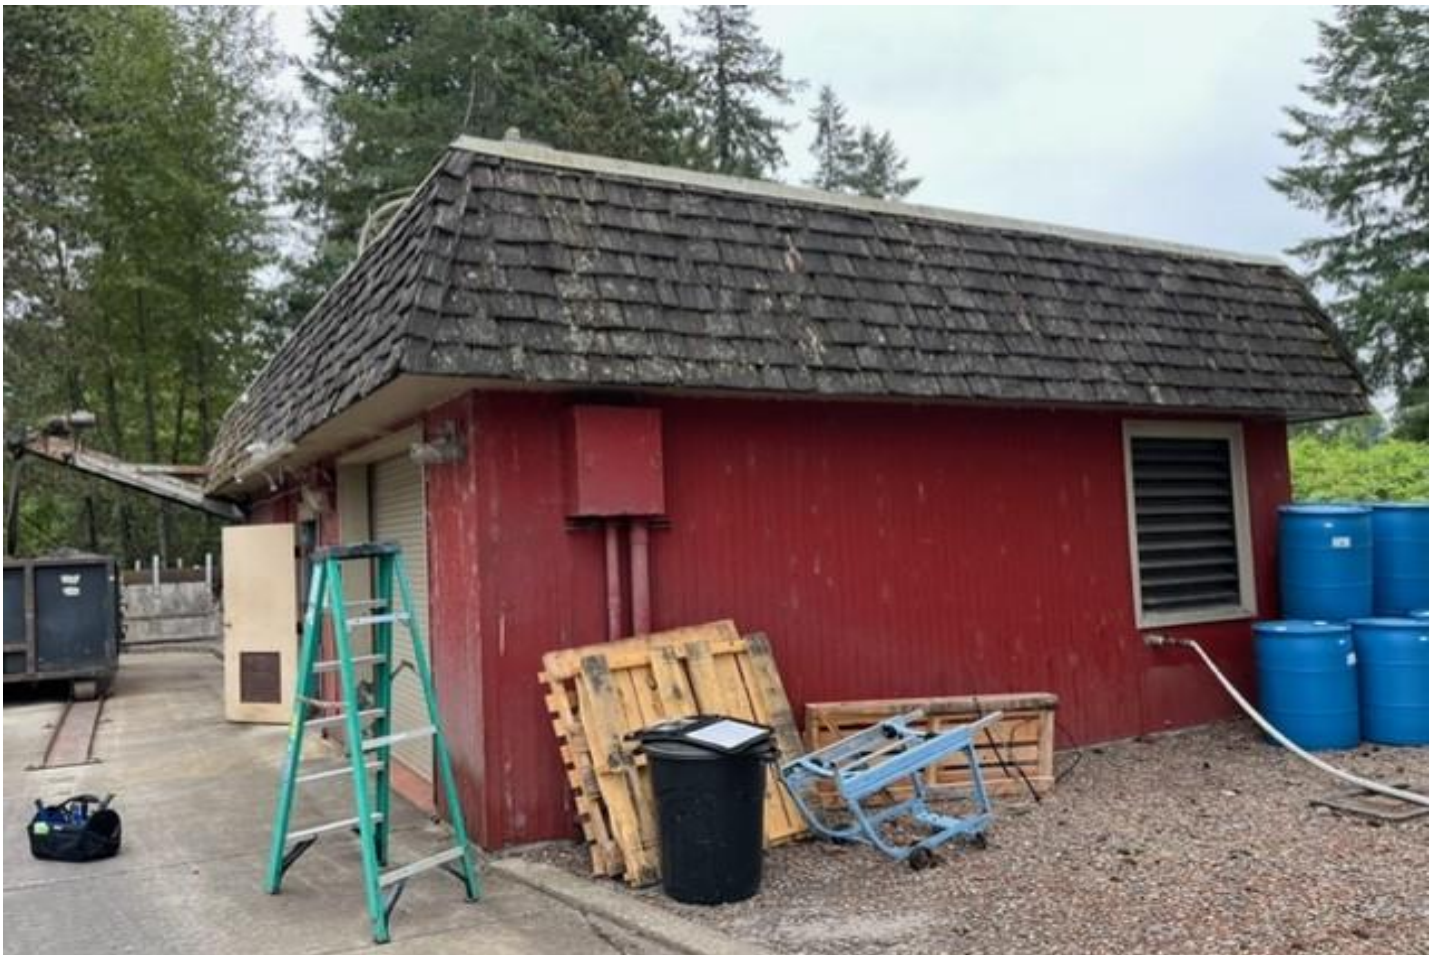
<i>MATERIAL- TYPE - COLOR</i>	<i>LOCATION Sq. ft.</i>	<i>COND. G/P</i>	<i>FRIABLE Y/N</i>	<i>PERCENT % ACM</i>
001	FRP Type Wall Paneling Tan	Lower Pump House Throughout	G	N	No Asbestos Detected
	<i>MATERIAL- TYPE - COLOR</i>	<i>LOCATION Sq. ft.</i>	<i>COND. G/P</i>	<i>FRIABLE Y/N</i>	<i>PERCENT % ACM</i>
002	Tar Paper - Black	Under Cedar Roofing	G	N	No Asbestos Detected

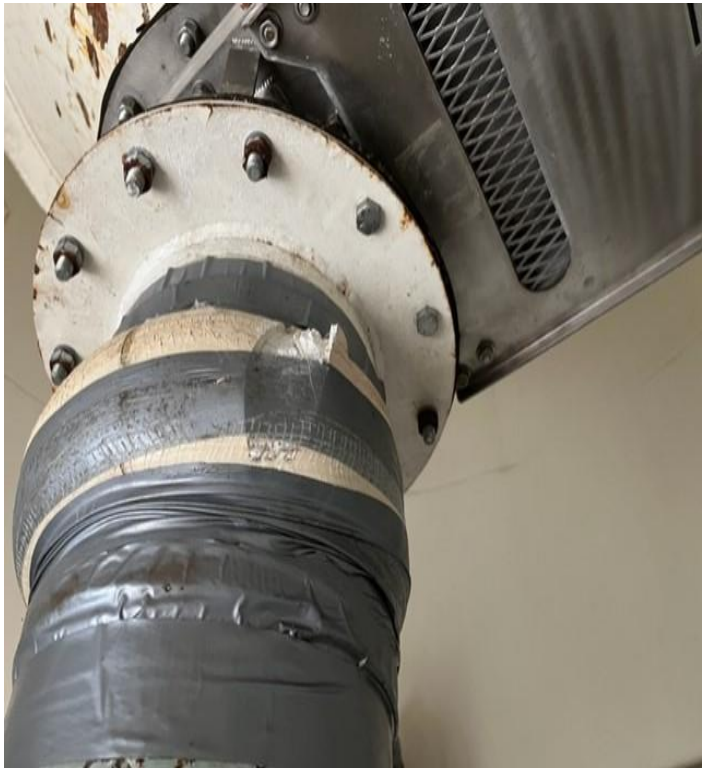
Lime Tower Insulation - Interior at funnel

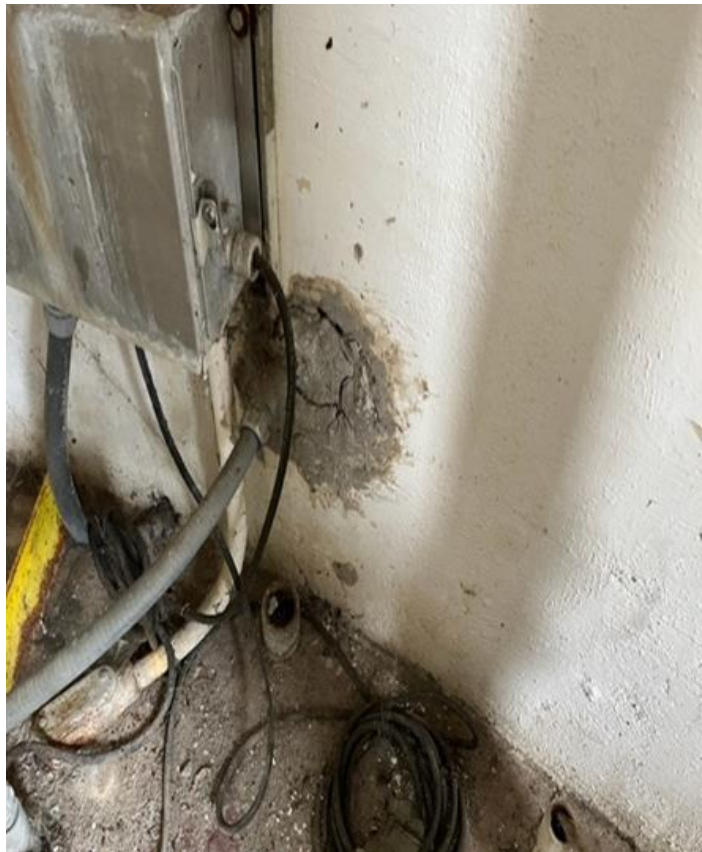
Right Holding Tank - Patch Material - Interior

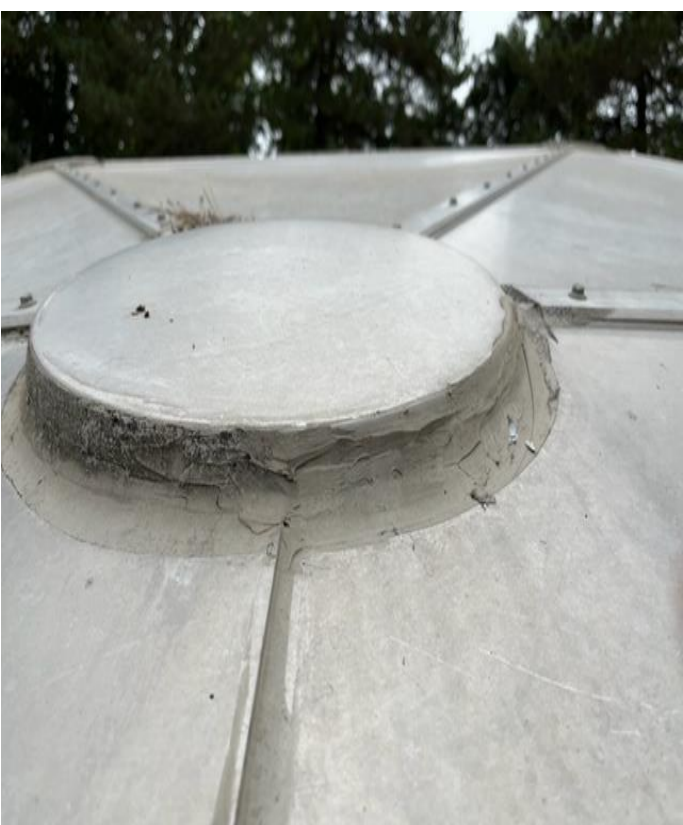
<i>MATERIAL- TYPE - COLOR</i>	<i>LOCATION Sq. ft.</i>	<i>COND. G/P</i>	<i>FRIABLE Y/N</i>	<i>PERCENT % ACM</i>
003	Caulking Material - Gray	Lower Holding Tank Lid Vents	G	N	No Asbestos Detected
	<i>MATERIAL- TYPE - COLOR</i>	<i>LOCATION Sq. ft.</i>	<i>COND. G/P</i>	<i>FRIABLE Y/N</i>	<i>PERCENT % ACM</i>
004	Insulation Material - Yellow Fibrous	Concrete Dual Holding Tanks - Interior	G	N	No Asbestos Detected
	<i>MATERIAL- TYPE - COLOR</i>	<i>LOCATION Sq. ft.</i>	<i>COND. G/P</i>	<i>FRIABLE Y/N</i>	<i>PERCENT % ACM</i>
005	Patch Material- Gray	Concrete Dual Holding Tanks Right Interior	G	N	No Asbestos Detected
	<i>MATERIAL- TYPE - COLOR</i>	<i>LOCATION Sq. ft.</i>	<i>COND. G/P</i>	<i>FRIABLE Y/N</i>	<i>PERCENT % ACM</i>
006	Powder Insulation - White	Lime Tower - Interior Valve	G	N	No Asbestos Detected
	<i>MATERIAL- TYPE - COLOR</i>	<i>LOCATION Sq. ft.</i>	<i>COND. G/P</i>	<i>FRIABLE Y/N</i>	<i>PERCENT % ACM</i>

Caulking Material

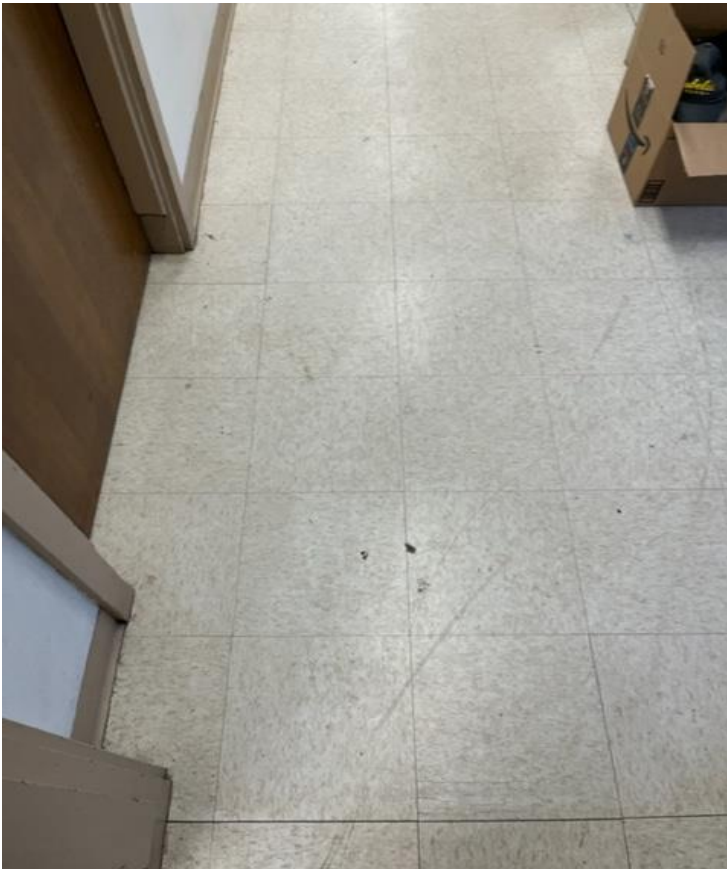
007	Vinyl Tile - White Black Mastic	Entry - Hallway Admin. Building 275	G	N	2% ACM - Vinyl Tile 5% ACM - Black Mastic
	<i>MATERIAL- TYPE - COLOR</i>	<i>LOCATION Sq. ft.</i>	<i>COND. G/P</i>	<i>FRIABLE Y/N</i>	<i>PERCENT % ACM</i>
008	Cove Base - Tan Brown Mastic	Floors - Admin. Building Throughout	G	N	No Asbestos Detected
	<i>MATERIAL- TYPE - COLOR</i>	<i>LOCATION Sq. ft.</i>	<i>COND. G/P</i>	<i>FRIABLE Y/N</i>	<i>PERCENT % ACM</i>
009	Vinyl Flooring - Yellow	Locker Room Admin. Building	G	N	No Asbestos Detected
	<i>MATERIAL- TYPE - COLOR</i>	<i>LOCATION Sq. ft.</i>	<i>COND. G/P</i>	<i>FRIABLE Y/N</i>	<i>PERCENT % ACM</i>
010	Floor Coating - Gray	Break Room Admin. Building	G	N	No Asbestos Detected

Admin Building - Vinyl Tile - 12x12

Sample ID	Collected	Cust. ID	Location	Asbestos Fibers	Other Materials
484136-007	08/09/22	007	Entry Hallway Admin		
Layer 1:	Vinyl Tile			2% CHRYSOTILE	98% NON FIBROUS MATERIAL
	White, Organically Bound				
Layer 2:	Mastic			5% CHRYSOTILE	95% NON FIBROUS MATERIAL
	Black, Bituminous				
484136-008	08/09/22	008	Floor Throughout Admin		
Layer 1:	Cove Base			No Asbestos Detected	100% NON FIBROUS MATERIAL
	Tan, Rubbery				
Layer 2:	Mastic			No Asbestos Detected	100% NON FIBROUS MATERIAL
	Brown, Brittle				
484136-009	08/09/22	009	Locker Room Admin		
Layer 1:	Vinyl Flooring			No Asbestos Detected	100% NON FIBROUS MATERIAL
	Yellow, Organically Bound				
Layer 2:	Hard Material			No Asbestos Detected	100% NON FIBROUS MATERIAL
	Gray, Hard/Granular				
484136-010	08/09/22	010	Break Room		
Layer 1:	Floor coating			No Asbestos Detected	100% NON FIBROUS MATERIAL
	Gray, Soft				
484136-011	08/09/22	011	Lab Room Admin		
Layer 1:	Vinyl Flooring			20% CHRYSOTILE	20% CELLULOSE FIBER

Abate Tek LLC findings after this inspection showed that the samples listed above (**007,011**) were tested and found to be (**Positive**) or greater than >1% asbestos content. Therefore, Abate Tek LLC recommends this material be removed by a licensed abatement contractor.

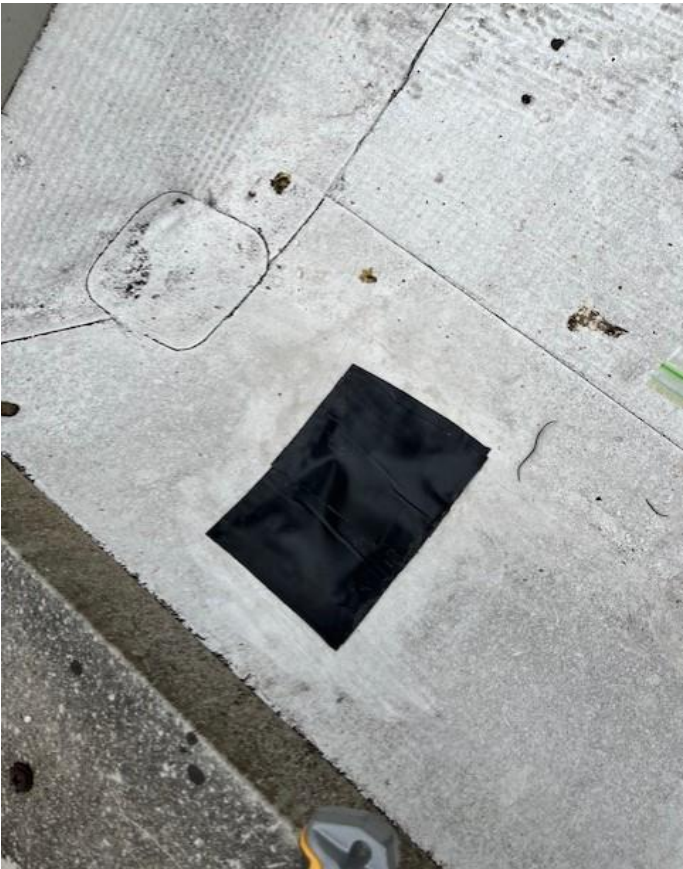
015	Roofing Membrane - White Composite White - Felt	Roofing - Red buildings	G	N	No Asbestos Detected
	<i>MATERIAL- TYPE - COLOR</i>	<i>LOCATION Sq. ft.</i>	<i>COND. G/P</i>	<i>FRIABLE Y/N</i>	<i>PERCENT % ACM</i>
016	Roofing Tar - Black Bituminous	Patched Areas Admin. Building	G	N	No Asbestos Detected
	<i>MATERIAL- TYPE - COLOR</i>	<i>LOCATION Sq. ft.</i>	<i>COND. G/P</i>	<i>FRIABLE Y/N</i>	<i>PERCENT % ACM</i>
017	Drywall - Mud - White	Public Works - Shop Admin. Building	G	N	No Asbestos Detected

Admin Building Membrane / Composite Roof
